Boeing 737 MAX Safe to Fly?

In March 2019, the Boeing 737 MAX aircraft, a newly designed aircraft from a highly respected manufacturer, was grounded after being implicated in two fatal accidents. After 20 months, the aircraft is now approved by the US regulator for commercial operations and has seen its first commercial flights. Paul Hampton and Dewi Daniels provides an update on events based on recent developments and ask if the aircraft is really safe to fly again.

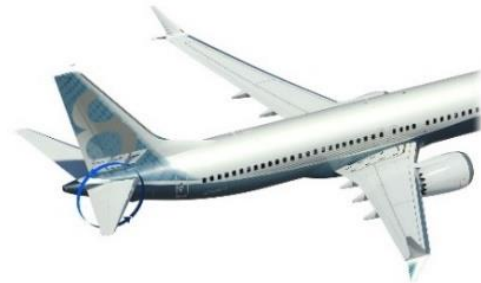
To stay competitive in the market, the Boeing 737 MAX uses CFM Leap 1B engines that are more fuel efficient, but have larger fan diameters, and so need to be mounted further forward than on previous variants of the aircraft to provide sufficient ground clearance.

During wind tunnel testing however, Boeing found that the Boeing 737 MAX tended to pitch up during high angles of attack, which violated federal aviation regulations that demanded that the gradient of the stick force versus manoeuvring load factor must lie within satisfactory limits.

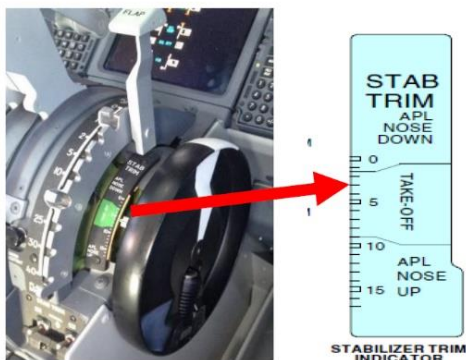
Manual trimming is carried out by turning the black wheels next to the stabiliser trim (STAB TRIM) indicator. 15 turns are required to move the STAB TRIM by 1 unit.

A STAB TRIM value of 0 indicates full nose down and a level trim value for level flight, is at around 5 units.

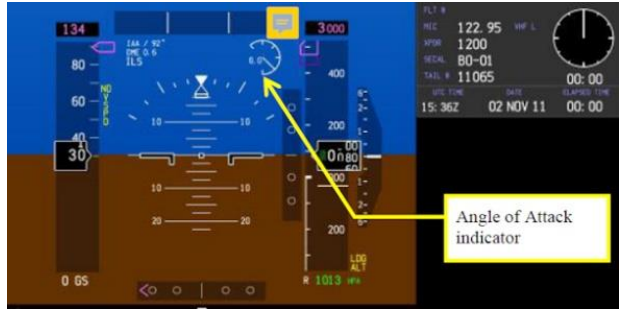
These interdependencies meant that AOA sensor errors could lead to, amongst others, activation of the control column stick shaker and clacker (to warn of a stall when one was not actually present), and alert lights for indicated airspeed, altitude and feel differential pressure values (feel differential pressure is used to simulate aerodynamic force effects on the control column).

One might expect that a mismatch in AOA readings would also be alerted to the crew, and indeed this had been a standard feature on the previous model, the 737 NG. However, on the 737 MAX, the AOA Disagree alert was only annunciated if the airline had ordered the optional AOA Indicator display. This option had not been taken up by the accident airlines and so no AOA alert was presented to the pilots in both accident flights.

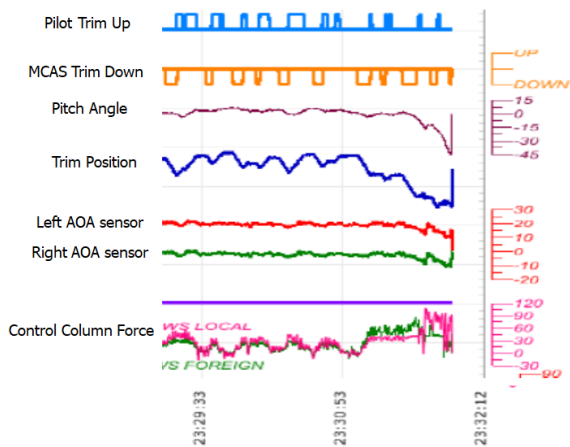
remaining flight. Airspeed and altitude mismatch alerts were also reported to the crew. The erroneous left-hand AOA sensor led to repeated attempts by MCAS to command the aircraft nose down. This was repeatedly countered by the pilot using electric nose-up trim and applying more nose-up aft force to the control column, while the First Officer tried to follow the non-normal checklist for the air-speed unreliable alerts. Increased workload and distractions from ATC communications meant that the checklist was never completed. Later, the Captain handed over control to the First Officer. As the aircraft accelerated, the resulting aerodynamic forces that built up made it impossible for the pilot to pull back on the control column; and a minute later, the aircraft was lost with 189 fatalities.

The figure opposite, adapted from the flight recorder data, shows the final minutes of the flight. The manual trimming conducted by the crew is shown at the top in blue, with MCAS trimming shown in orange. The pitch angle and trim positions show how the crew finally lost their trimming battle with MCAS.
