Boeing 737 MAX Safe to Fly?

In March 2019, the Boeing 737 MAX aircraft, a newly designed aircraft from a highly respected manufacturer, was grounded after being implicated in two fatal accidents. After 20 months, the aircraft is now approved by the US regulator for commercial operations and has seen its first commercial flights. Paul Hampton and Dewi Daniels provides an update on events based on recent developments and ask if the aircraft is really safe to fly again.

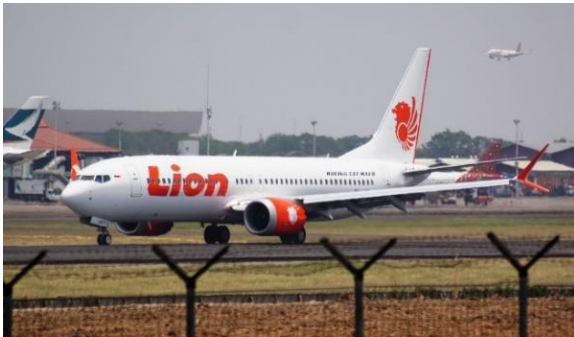
Lion Air Flight 610 – Accident Flight

Lion Air Flight 610 was a scheduled domestic flight from Jakarta to Pangkal Pinang on 29 October 2018. This Boeing 737 MAX aircraft registered PK-LQP was a new aircraft whose Certificate of Airworthiness had been issued on 15th August 2018.

After earlier problems with a faulty AOA sensor, the aircraft had been refitted with a refurbished sensor, was most likely miscalibrated by the maintenance organisation used by the airline resulting in a 21 degree bias on the left-hand side AOA sensor.

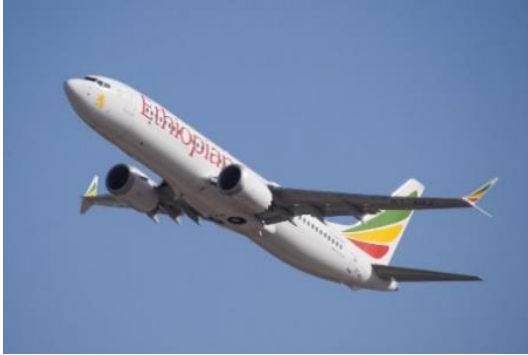
Ethiopian Airlines Flight 302- Accident Flight

Ethiopian Airlines Flight 302 was a scheduled international flight from Addis Ababa, Ethiopia to Nairobi, Kenya on 10th March 2019. The Boeing 737 MAX aircraft registered ET-AVJ was another new aircraft, which had been delivered to Ethiopian Airlines on 15th November 2018.

Again, shortly after take-off, the AOA sensors readings began to deviate with a difference being greater than 59 degrees for the rest of the flight. As with
